# GB Resort Condominium Hotel Association, Inc.

Inspected: August 15, 2024 • Revised on: October 10, 2024  
Key Biscayne, FL

**STRUCTURAL INTEGRITY  
RESERVE STUDY**

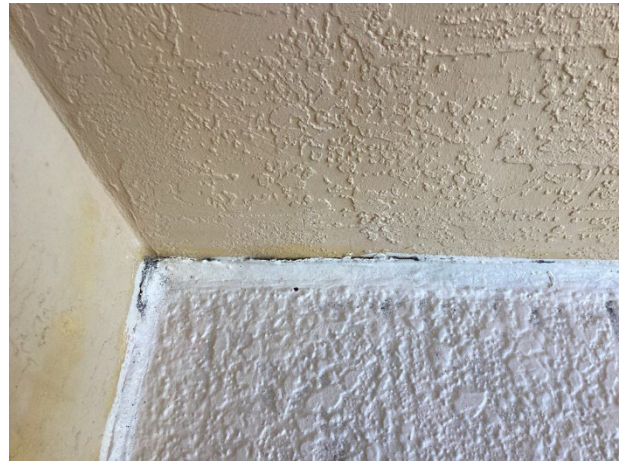
Edge sealant deterioration

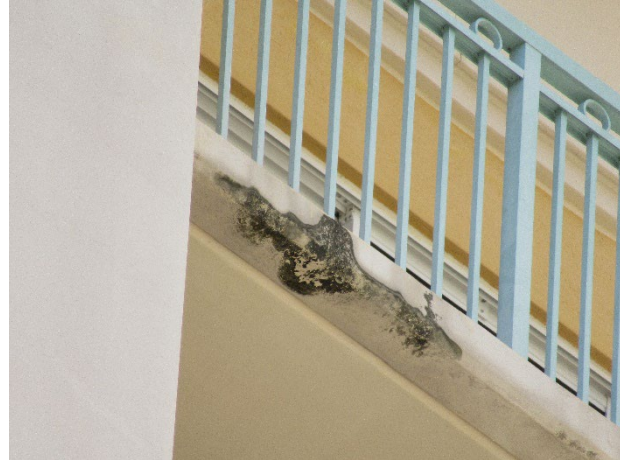
**Condition:** Fair to poor overall. We note the following:

**Concrete spall at balcony underside**

**Useful Life:** Capital repairs including a close-up visual inspection, patching of delaminated concrete, routing and filling of cracked concrete, and waterproof coating applications every 10- to 15-years.

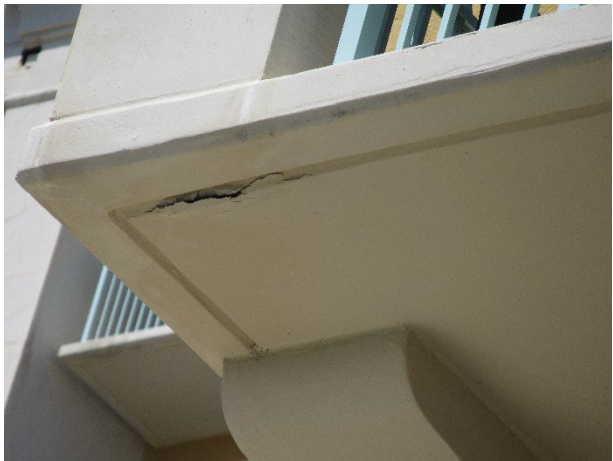
**Concrete cracks at balcony underside**

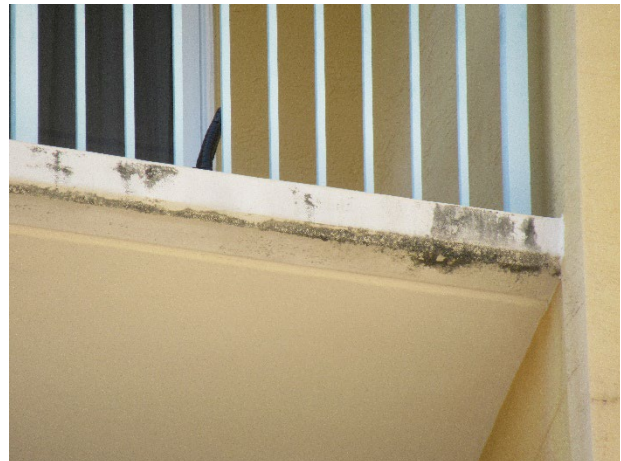
**Water stains at balcony underside**

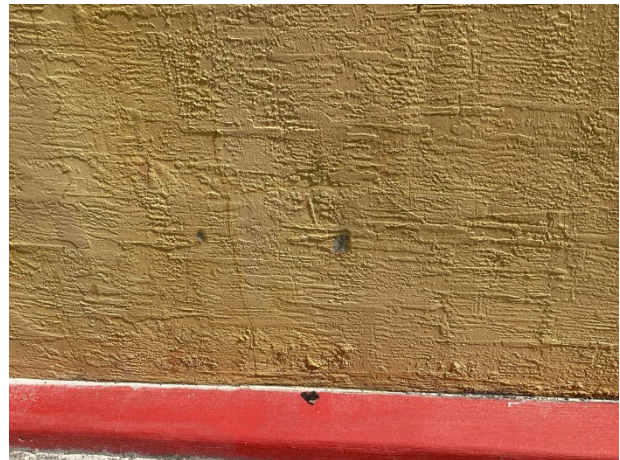
- Minor cracks are evident
- Isolated damage or missing is evident
- Sealants are in fair condition

**Stucco damage**

**Useful Life:** We recommend inspections, repairs and paint finish applications every five- to seven-years.

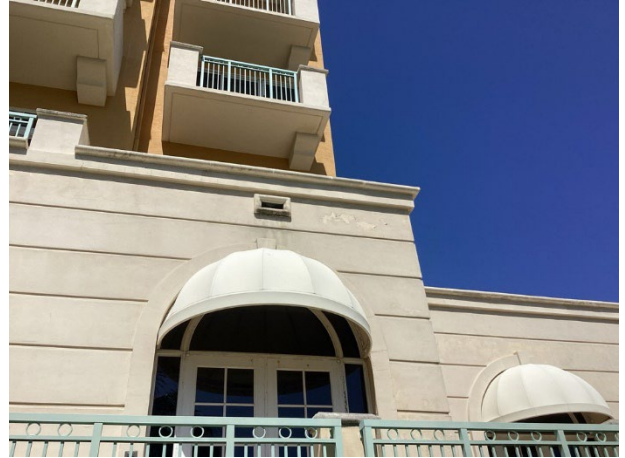
**Finish deterioration**

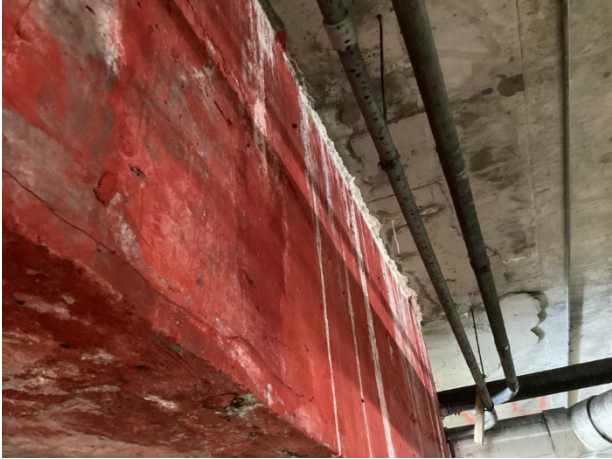
**Efflorescence at spa jacuzzi underside**

**Useful Life:** Repairs to the various concrete surfaces every 10- to 15-years

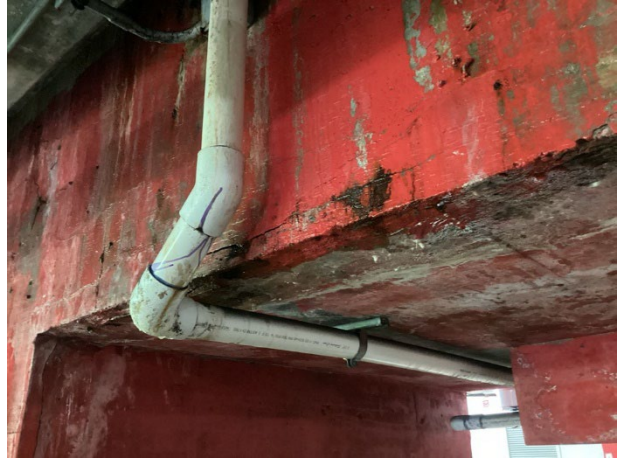
**Concrete cracks with active leaks and stalactites at spa jacuzzi underside**

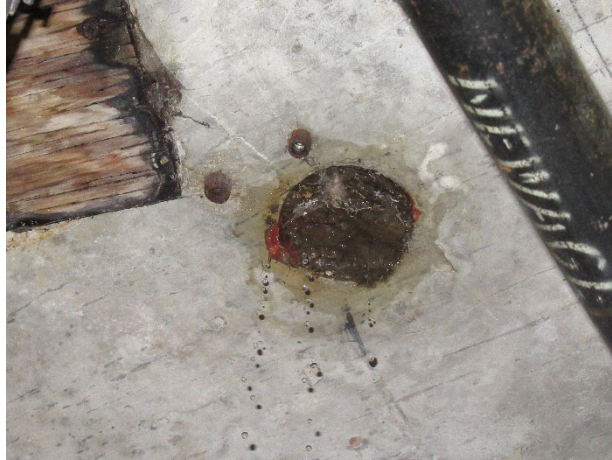
**Active leaks underneath men's spa showers**

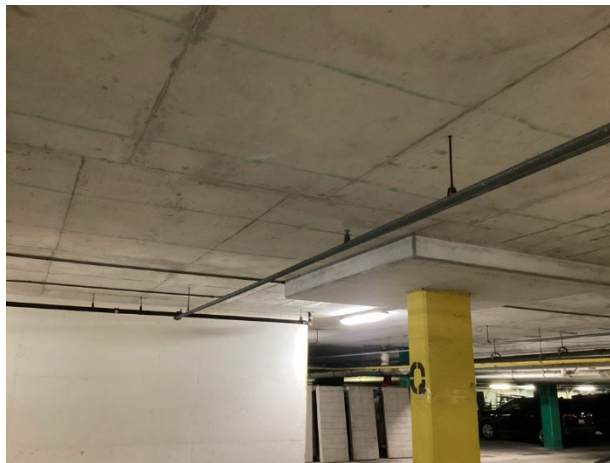
- Paint finishes are not present at the fire suppression system piping. We recommend the Association consider painting the system components to help achieve a longer useful life as they partially exhibit rust and deterioration.
- No significant history of pipe replacement was reported
- We note isolated areas of sprinkler head replacement
- No areas of pipe leaks or failures were observed
- No significant hanger rust was observed

**Fire suppression system**

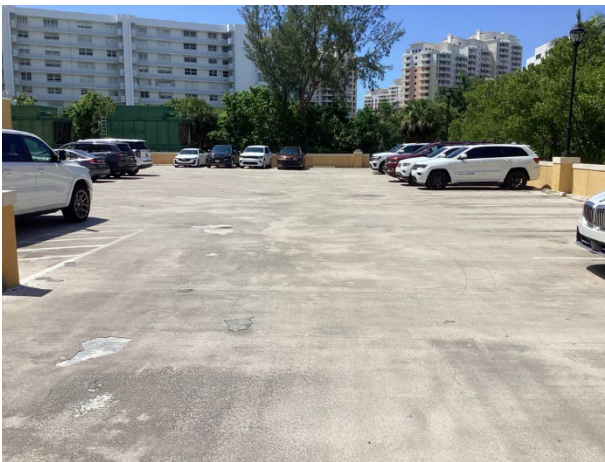
**Condition:** Fair to poor overall with periodic delamination and peeling evident.

**Traffic coating overview**

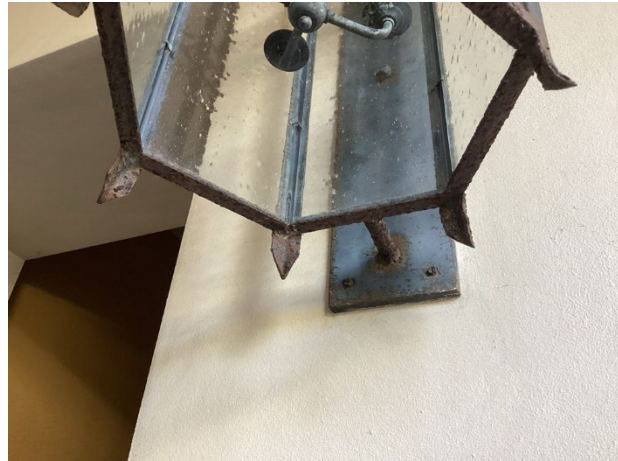
**Condition:** Fair overall with finish deterioration evident.

Finish deterioration

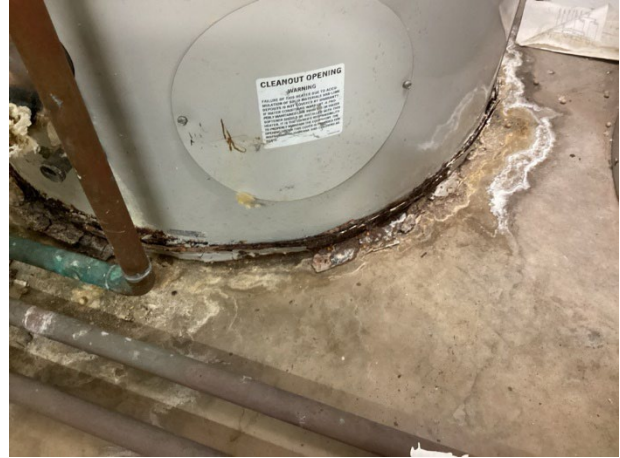
**Rust at tank base**

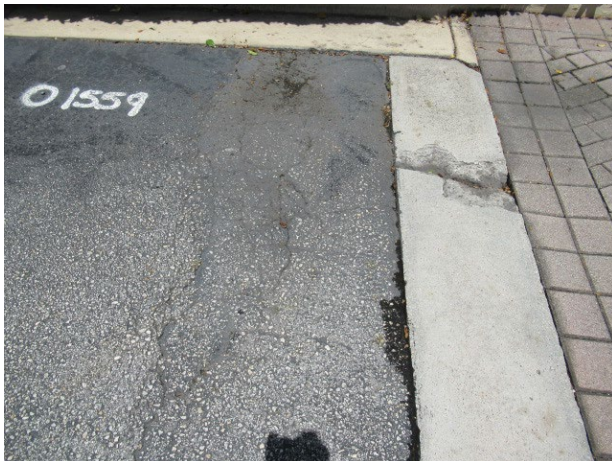
**Condition:** Good to fair overall with isolated cracks and edge deterioration evident

**Asphalt pavement cracks**

**Useful Life:** 15- to 20-years with the benefit of crack repairs events every three- to five-years

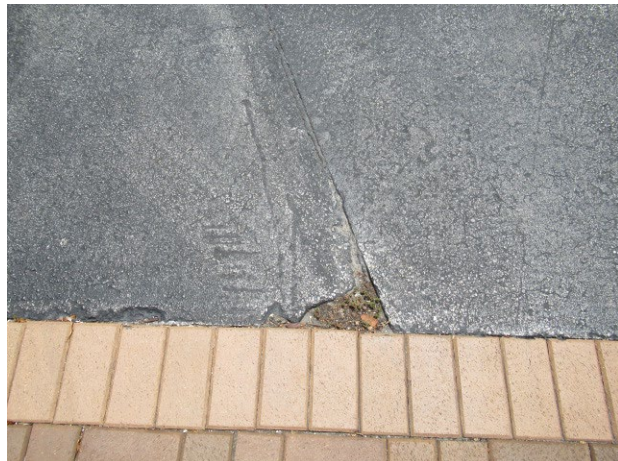
**Asphalt pavement edge deterioration**
