# GB Resort Condominium Hotel Association, Inc.

Inspected: August 15, 2024 • Revised on: October 10, 2024  
Key Biscayne, FL

**STRUCTURAL INTEGRITY  
RESERVE STUDY**

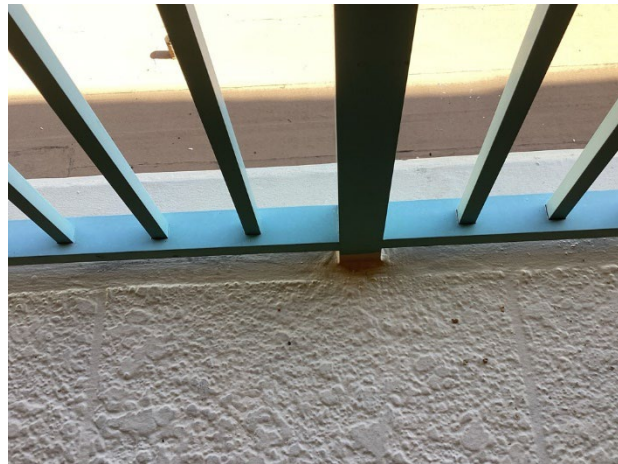
**Railing post embedded in concrete**

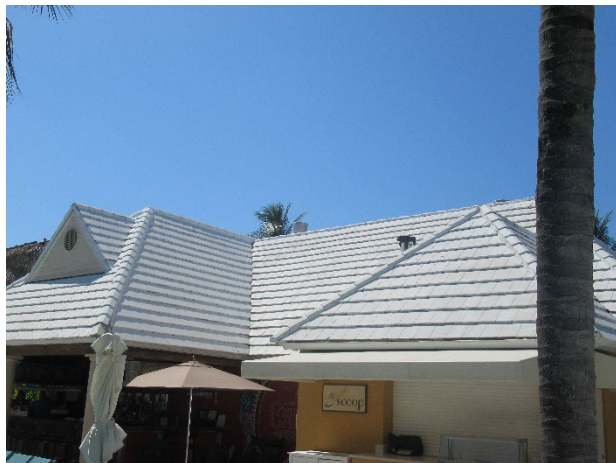
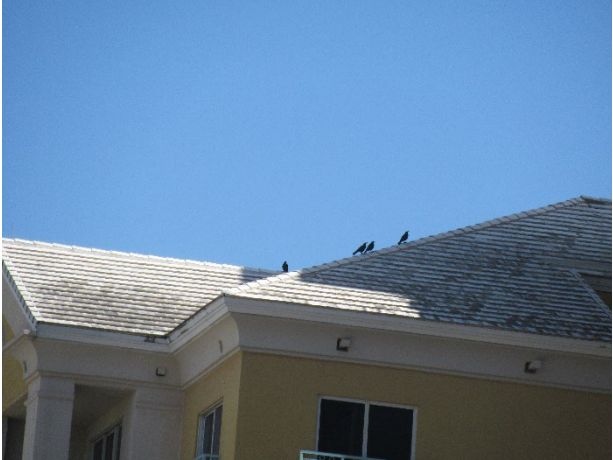
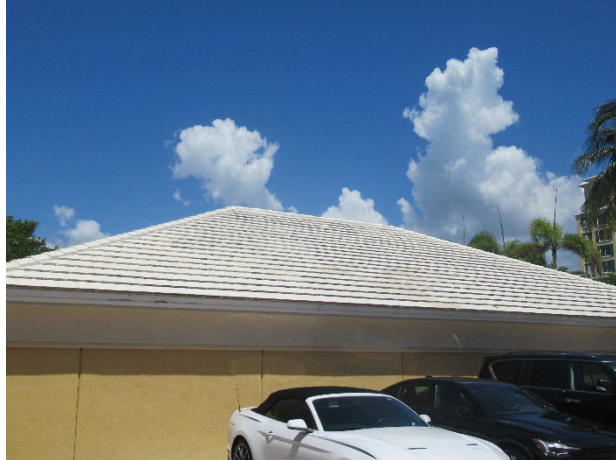
**Condition:** Good overall with no significant deterioration evident from our visual inspection from the ground.

**Concrete tile roof overview**

**History:** Original. We are informed the Association plans to replace the concrete tile roofs in 2025 as part of the restoration project. We recommend the Association should conduct inspections of the roofs semiannually and fund these inspections through the operating budget.

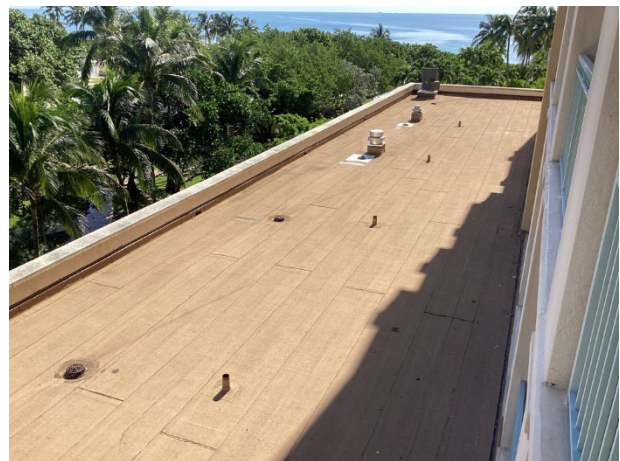
**Condition:** Good overall. Management and the Board report a limited history of leaks.

**Flat roof overview**

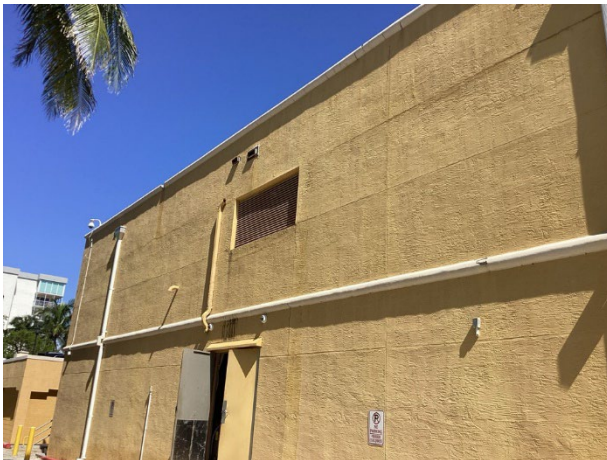
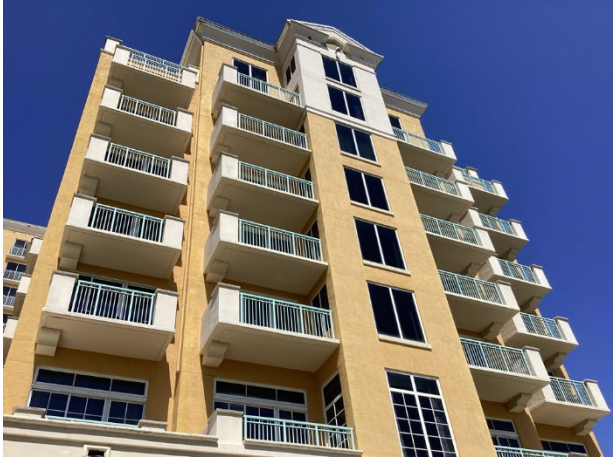
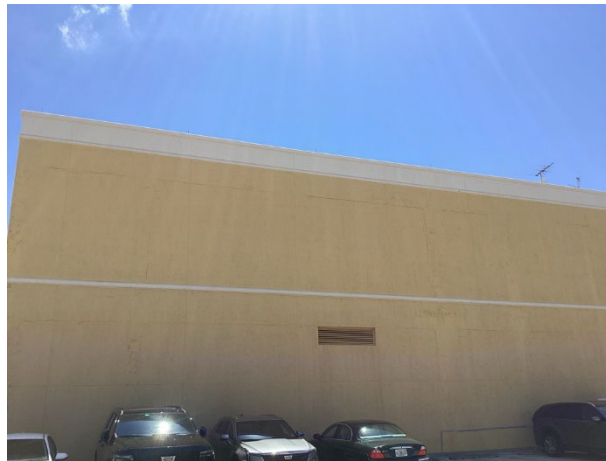
**Condition:** Fair overall. We note the following:

- Minor cracks are evident
- Isolated damage or missing is evident
- Sealants are in fair condition

**Stucco wall finishes**

**Useful Life:** We recommend inspections, repairs and paint finish applications every five- to seven-years.

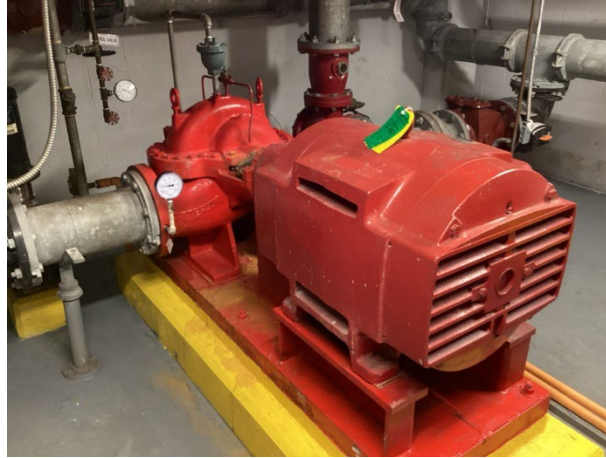
**Condition:** Reported satisfactory without operational deficiencies. We note the following:

- The inspection tag color is acceptable
- The Association does not report a history of leaks.

**Fire suppression pump**

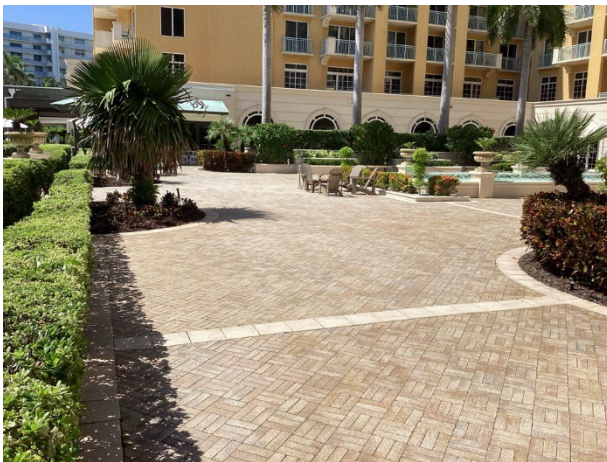
**Condition:** Good to fair overall condition and Management and the Board report recent water infiltration issues.

**Plaza deck overview**

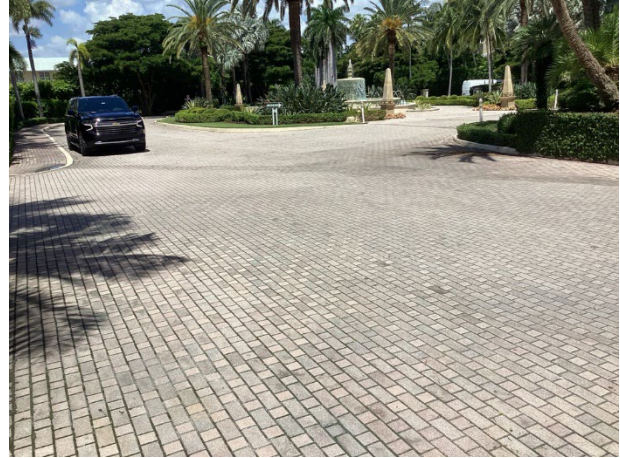
**Area with underlying membrane overview**

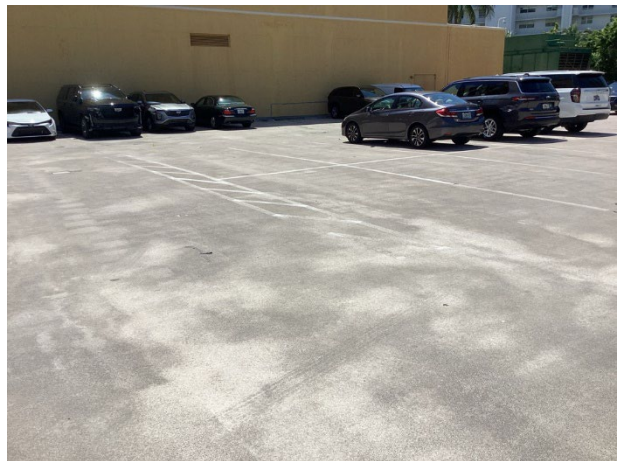
**Elevated garage floor overview**

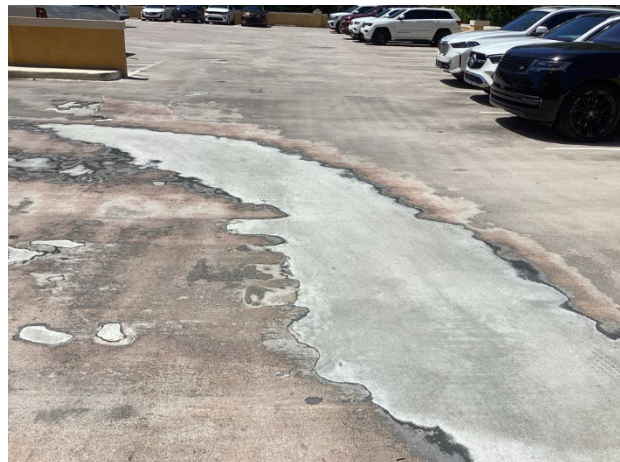
**Condition:** Fair to poor overall with periodic delamination and peeling evident.

**Traffic coating delamination**

be inspected. We recommend the Association plan future coating applications to include complete removal of the existing coating(s).

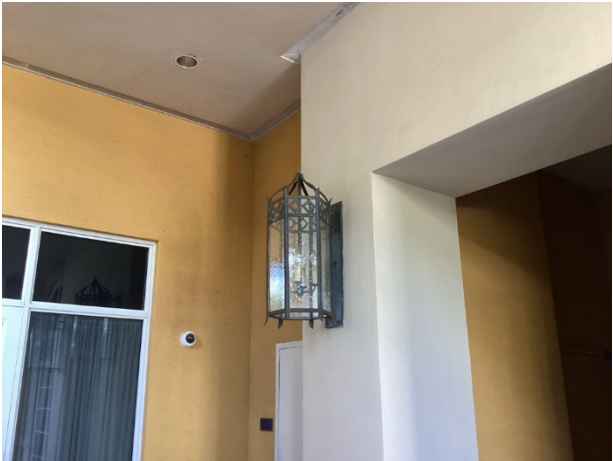
Exterior light fixture

**Condition:** Fair overall with finish deterioration evident.

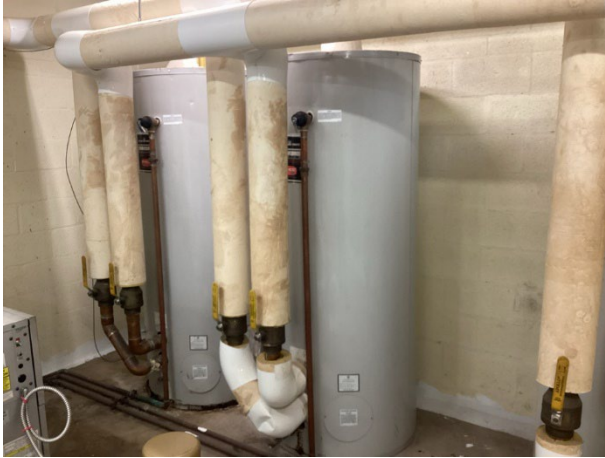
**Hot water storage tank**

**Condition:** Reported satisfactory without operational deficiencies. We note isolated rust at the tanks bases

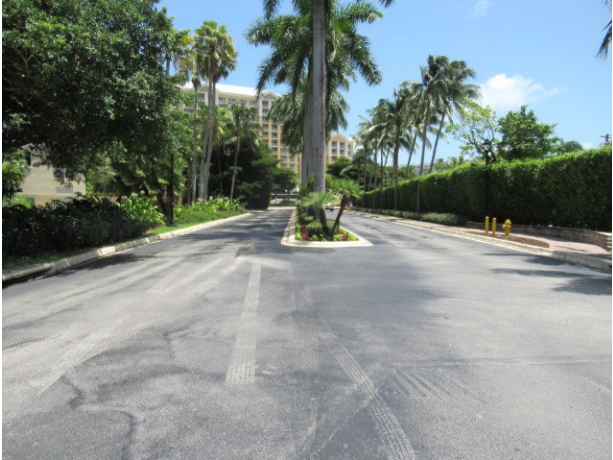
**Condition:** Good to fair overall with isolated cracks and edge deterioration evident

**Asphalt pavement overview**

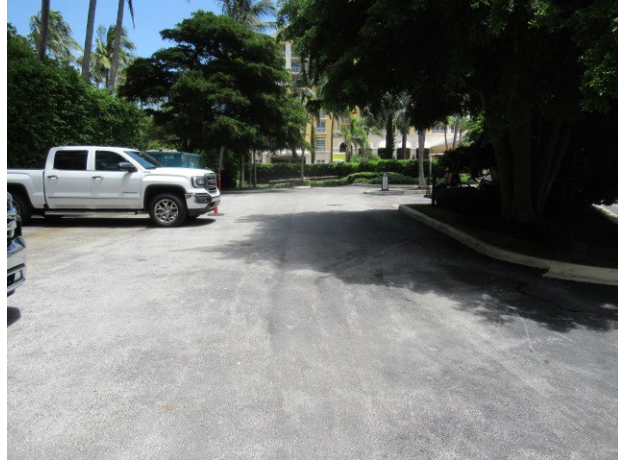
**Asphalt pavement overview**

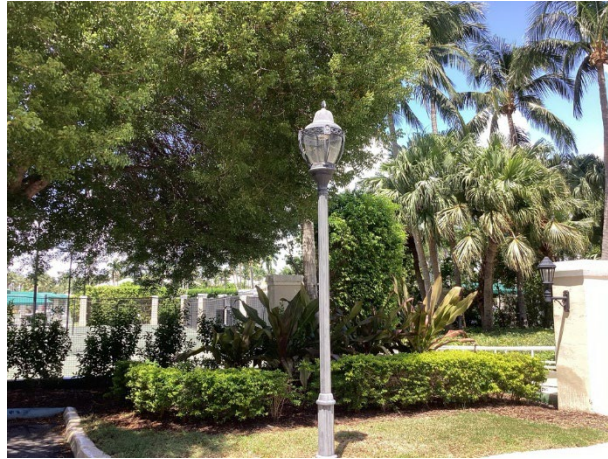
**Condition:** Good overall

**Light pole and fixture**

- As-needed:
  - Inspect and repair broken or dislodged fixtures, and leaning or damaged poles
  - Replaced burned out bulbs as needed

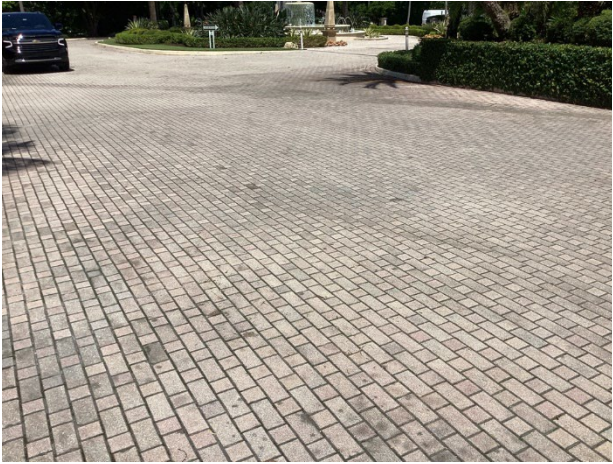
**Condition:** Fair overall

**Masonry pavers at main entrance**

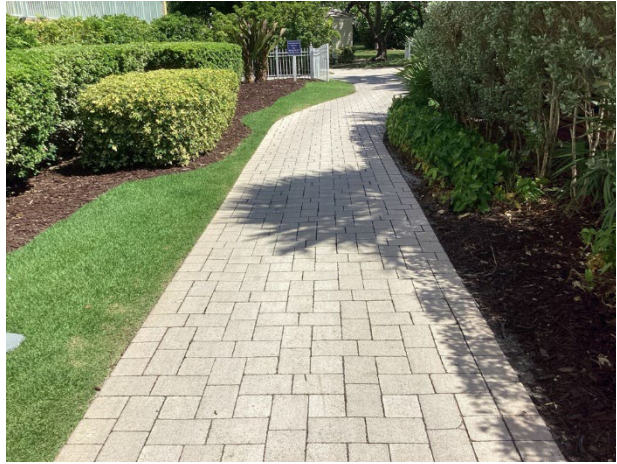
**Masonry pavers at east elevation of building**

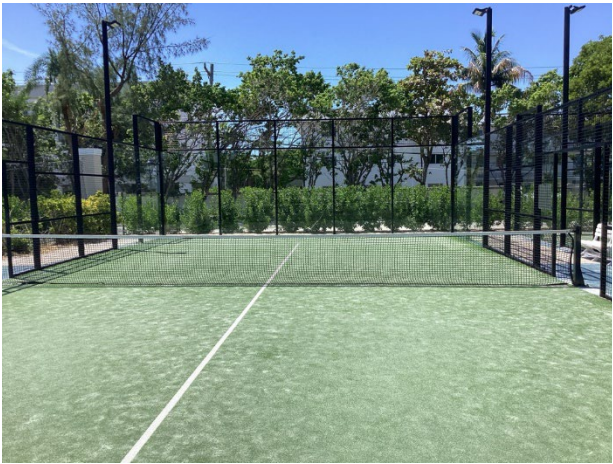
**Condition:** Good overall

**Padel court with light poles and fixtures**

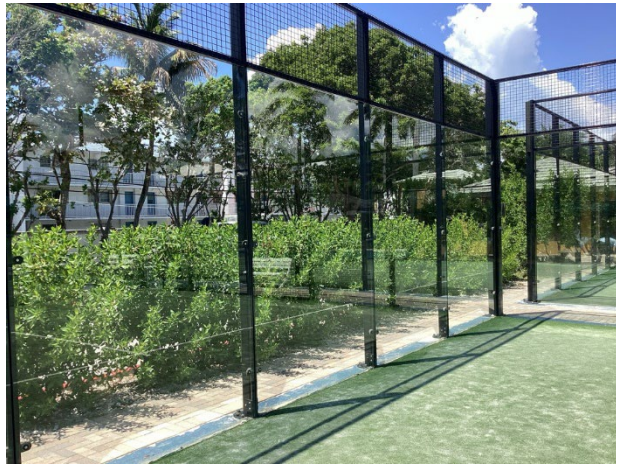
**Padel court glass enclosure**

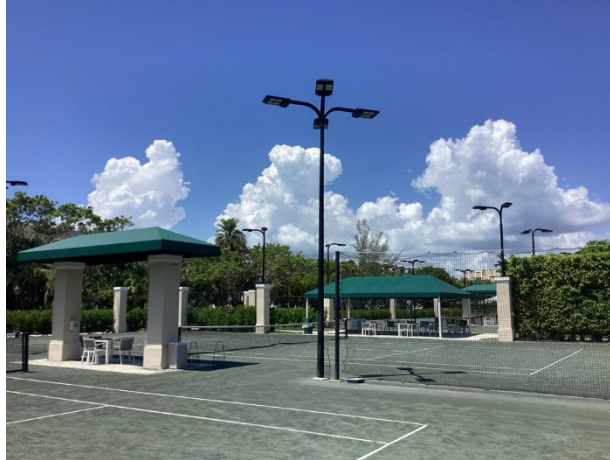
**Condition:** Good overall

**Sport court light poles and fixtures**

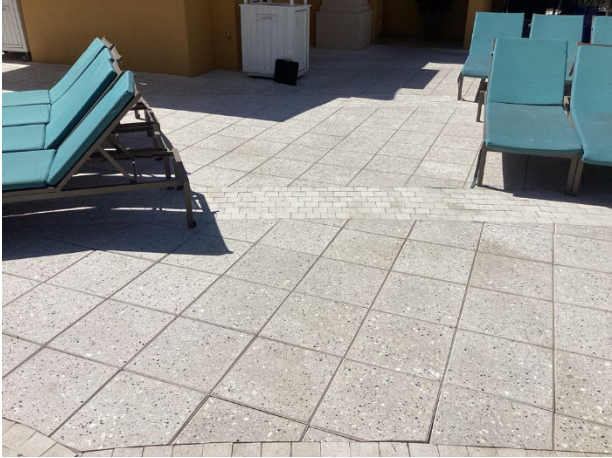
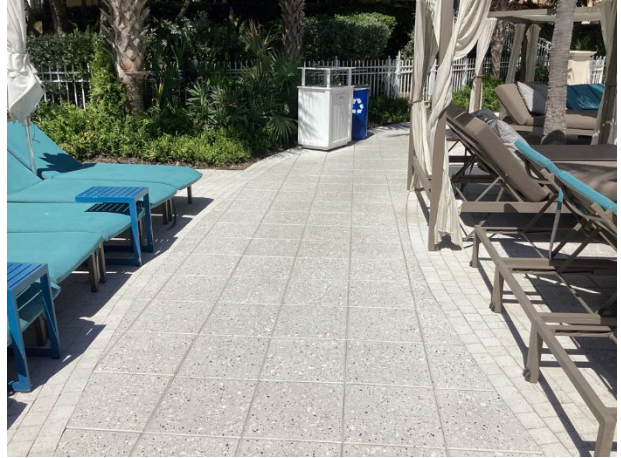
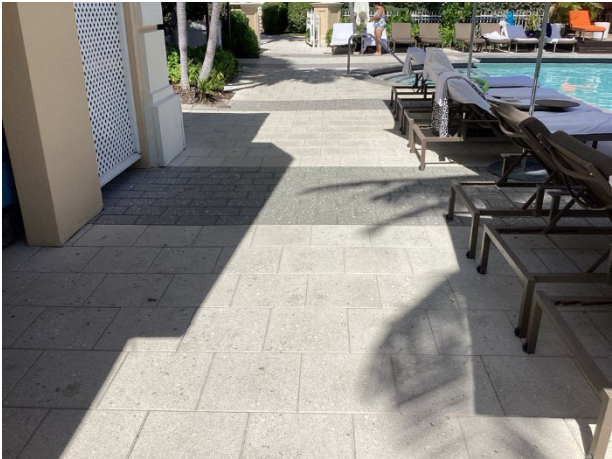
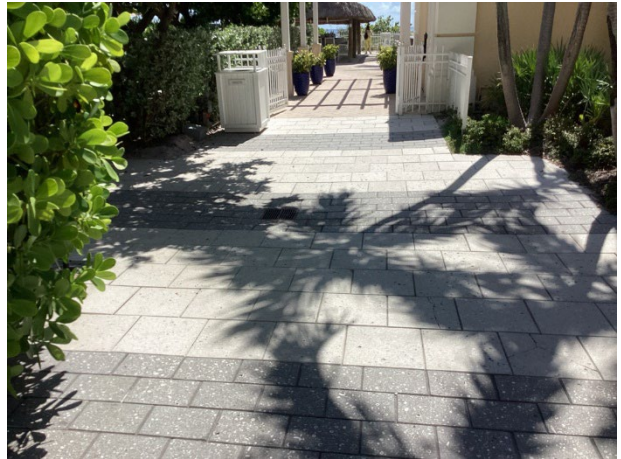
**Condition:** Good overall

**Paver pool deck overview**

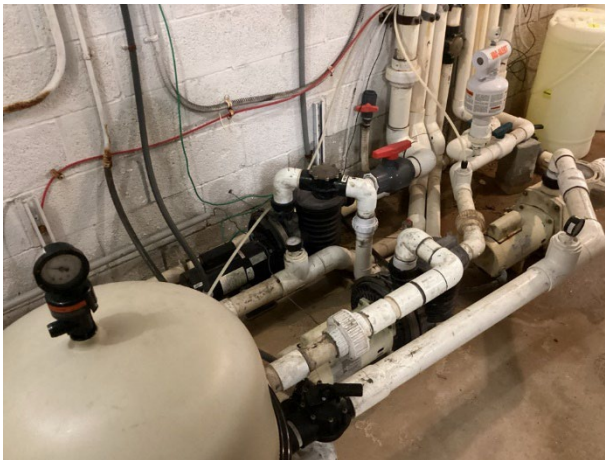
**Condition:** Reported satisfactory without operational deficiencies

**Pool mechanical equipment**

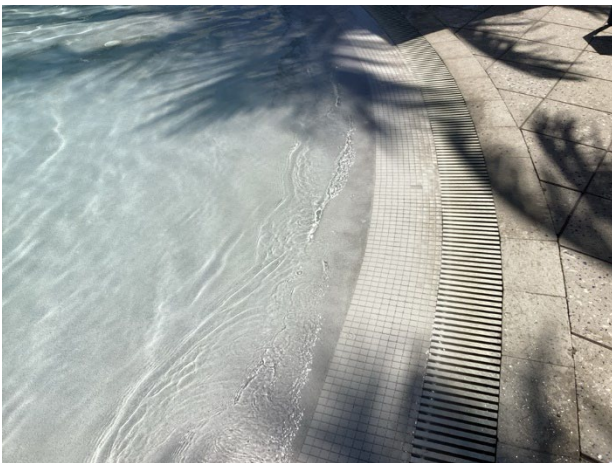
**Condition:** Good overall

**Pool plaster finish**

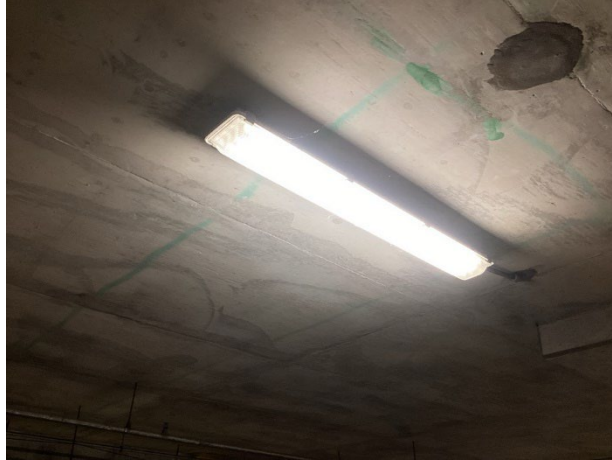
**Condition:** Reported satisfactory

**Garage light fixture**
