# GB Resort Condominium Hotel Association, Inc.

Inspected: August 15, 2024 • Revised on: October 10, 2024  
Key Biscayne, FL

**STRUCTURAL INTEGRITY  
RESERVE STUDY**

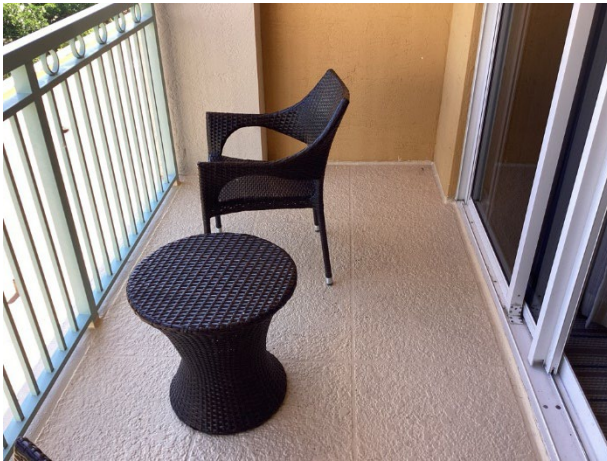
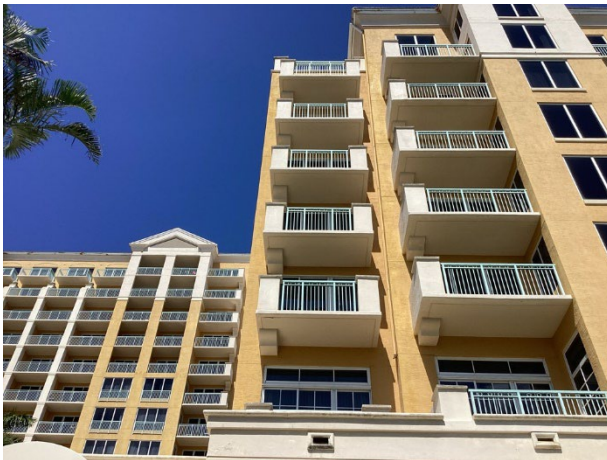
**Condition:** Fair to poor overall. We note the following:

- Sealants are in good to fair condition
- The coatings are in good condition
- Isolated concrete cracks are evident
- Minor concrete surface spalls are evident

Balcony overview

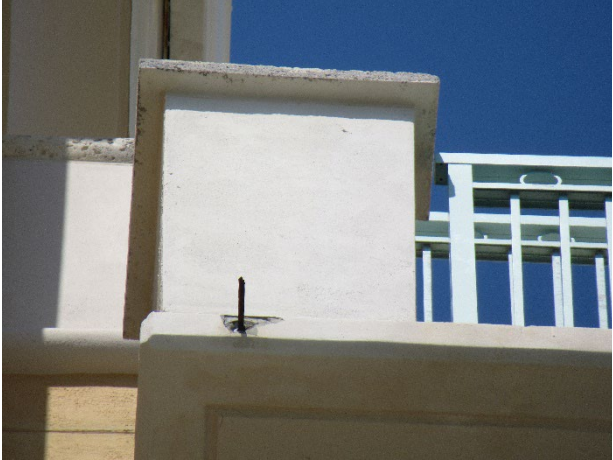
**Exposed reinforcements**

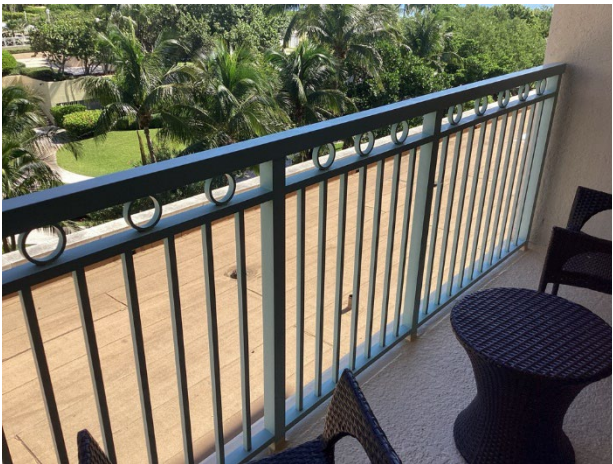
**Conditions:** The railings are in good overall condition and the railing finishes are in good condition

**Aluminum railings**

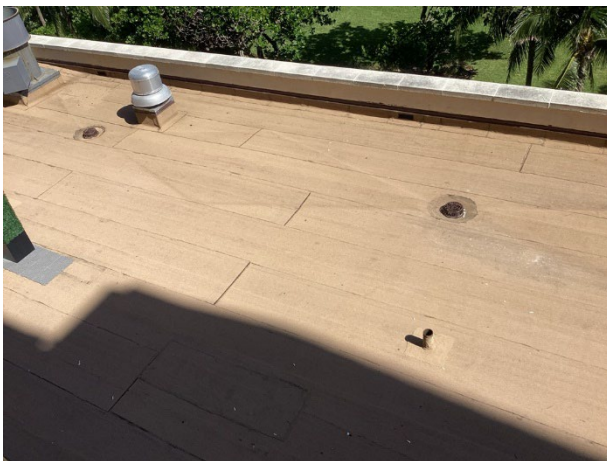
**Condition:** Good overall. Management and the Board report a limited history of leaks.

**Flat roof overview**

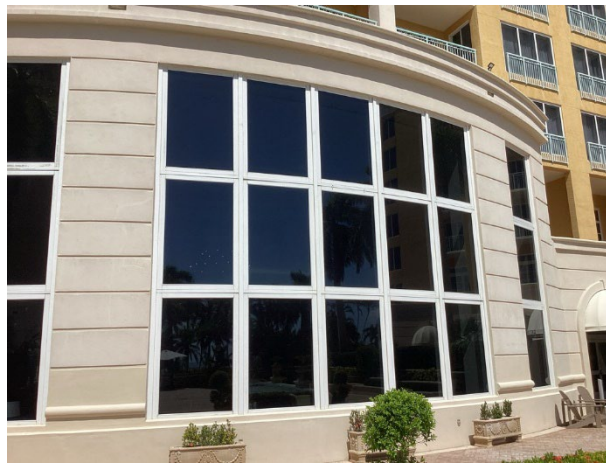
**Condition:** Good overall. We note the following:

- No reported history of operational issues.
- A history of water infiltration is reported. However, no report of active issues.

**Common windows**

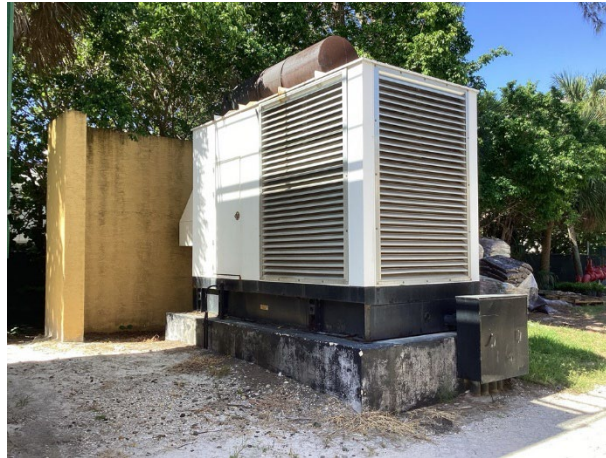
**Condition:** Reported satisfactory without operational deficiencies

**Generator**

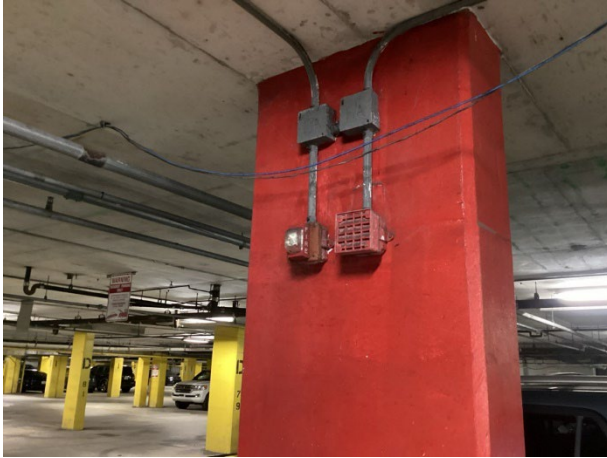
**Conditions:** Reported satisfactory without operational deficiencies. The date of the last annual inspection was unavailable at the time of our inspection. The life safety system was tagged acceptable during the most recent inspection.

**Emergency devices**

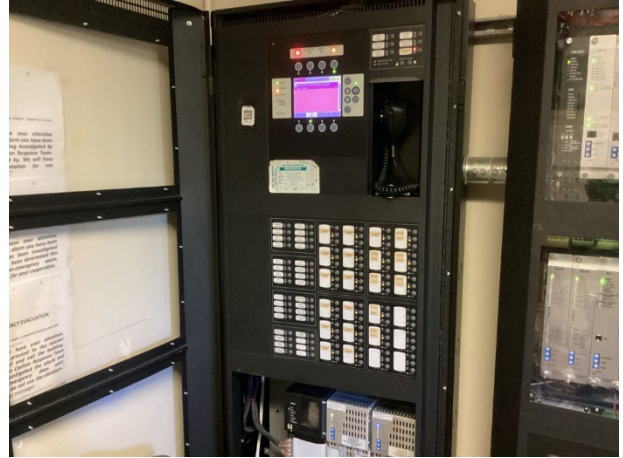
**Control panel**

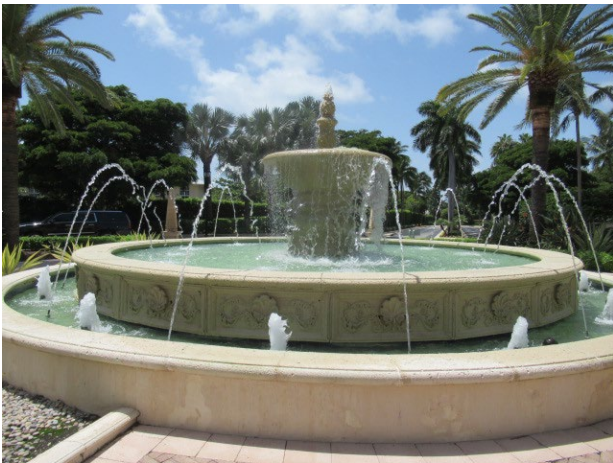
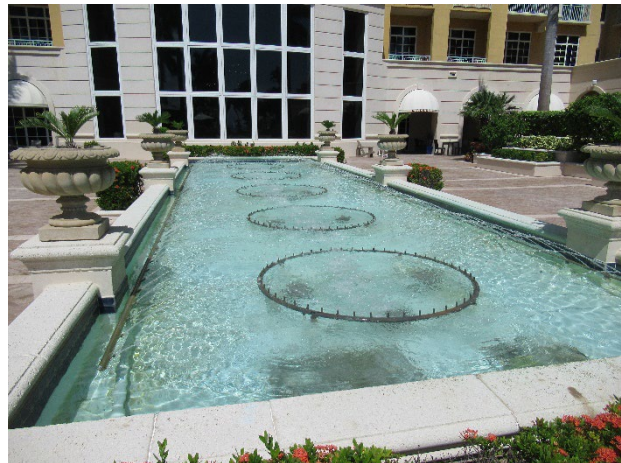
**Condition:** Fair overall

Fountain at traffic circle

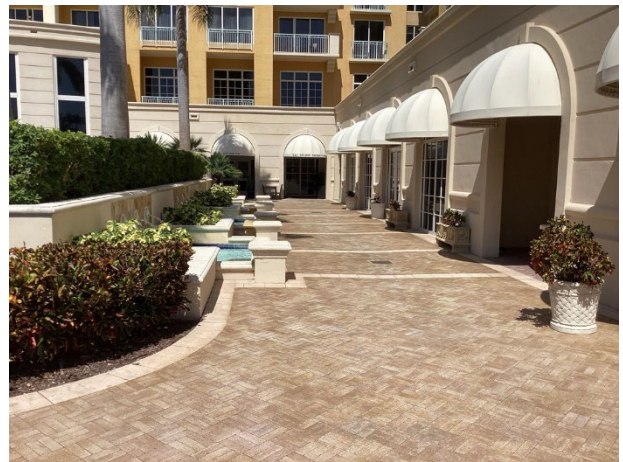
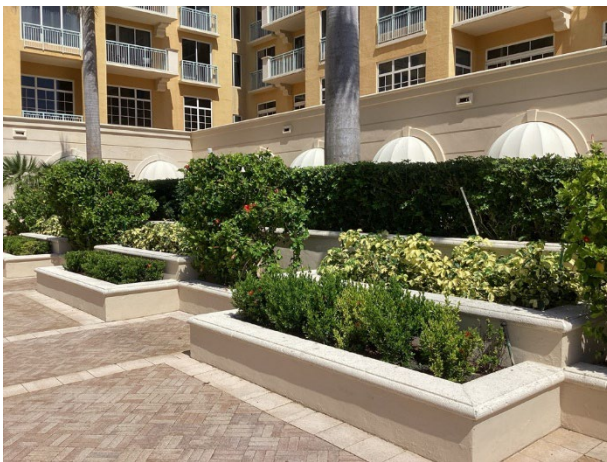
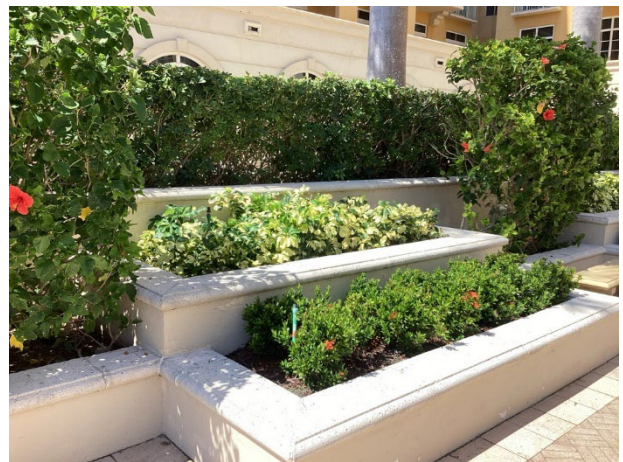
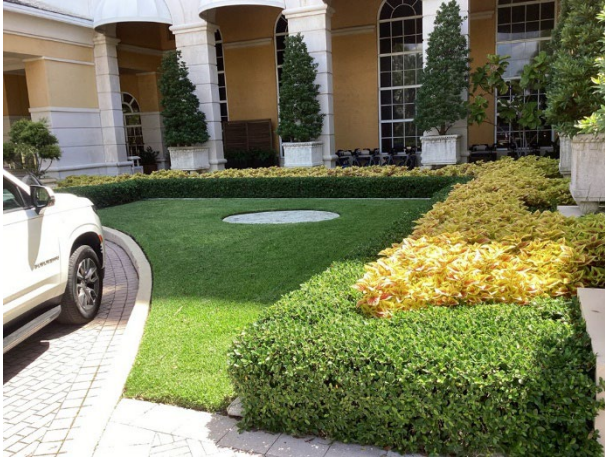
**Condition:** Good to fair overall condition and Management and the Board report recent water infiltration issues.

**Plaza deck overview**

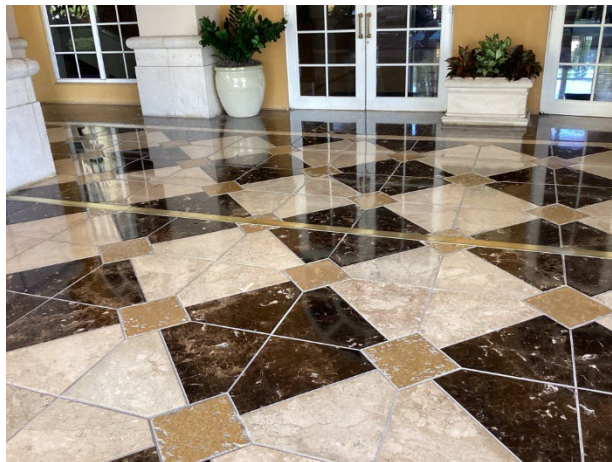
**Condition:** Good overall

Tile at porte cochere

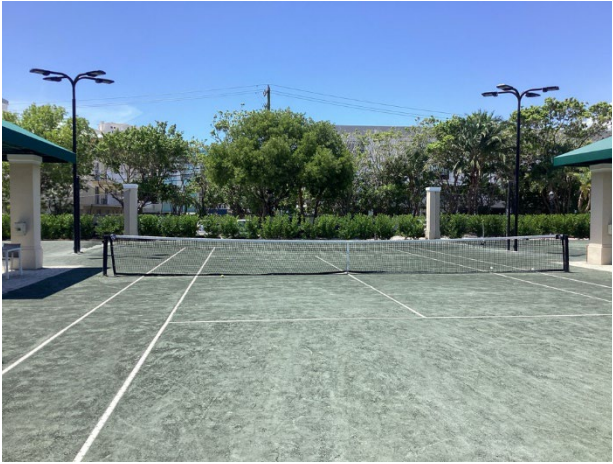
**Condition:** Good overall

**Clay tennis court**

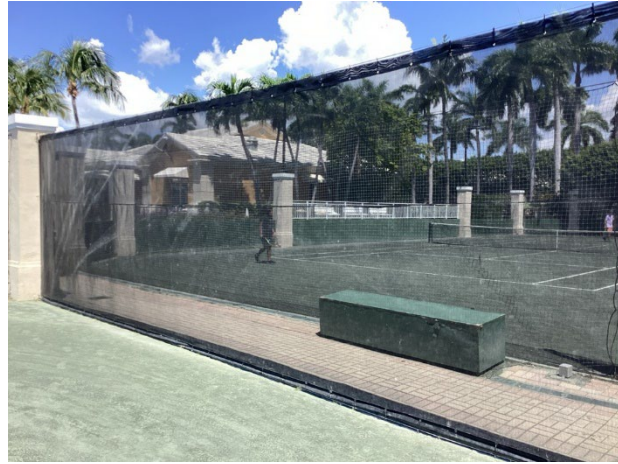
**Court fences**

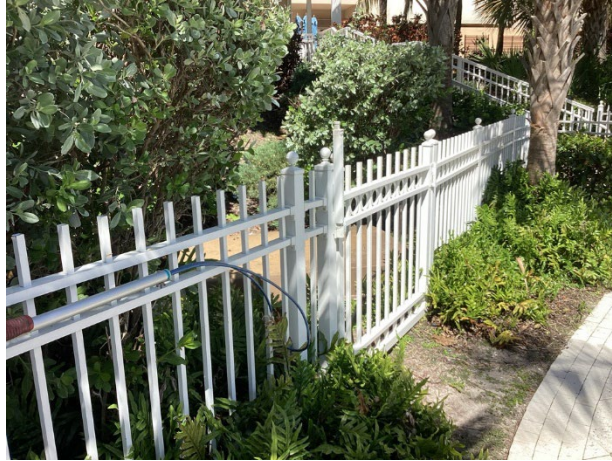
**Condition:** Good overall

**Pool fence**

- Annually:
  - Inspect and repair loose fasteners or sections, and damage
  - Repair leaning sections and clear vegetation from fence areas which could cause damage

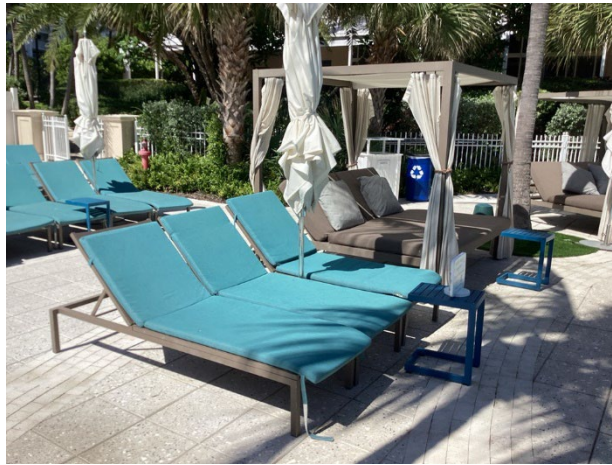
**Condition:** Good overall

**Pool furniture overview**

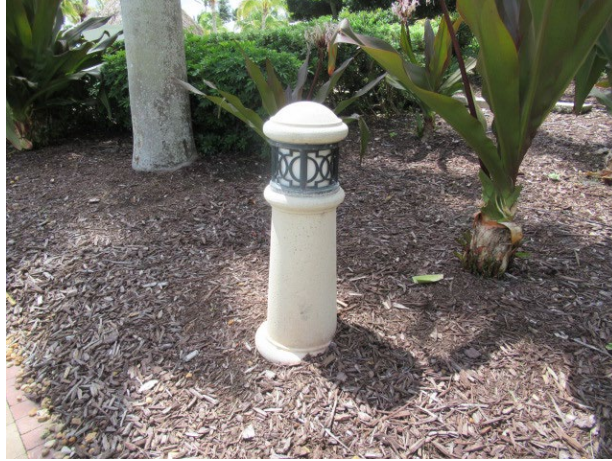
**Condition:** Fair overall.

**Bollard light fixture**

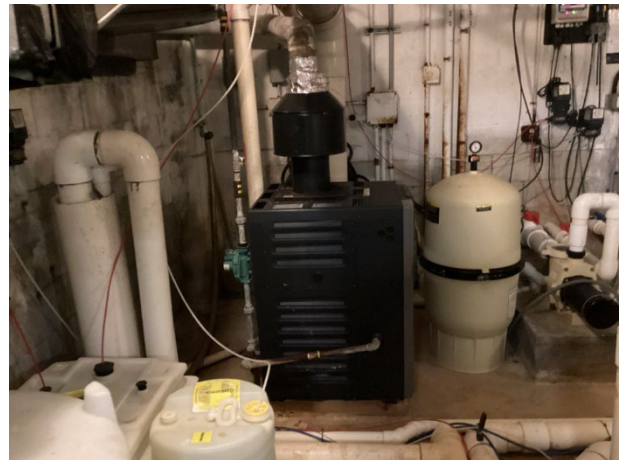
**Condition:** Reported satisfactory without operational deficiencies

**Pool heater**

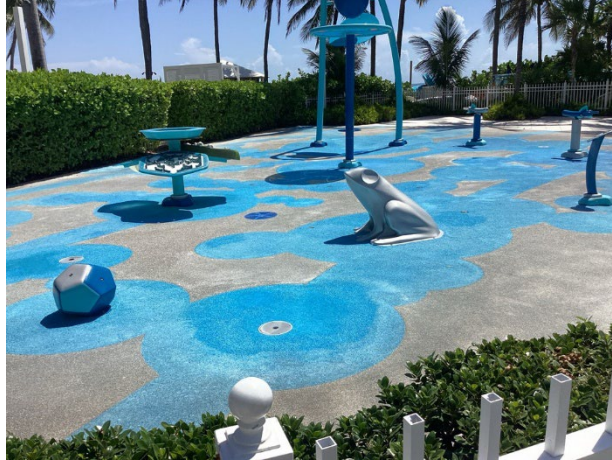
**Conditions:** Good overall

**Splash pad overview**
